vol. 27 issue 2

Journal of Cosmetic Dentistry

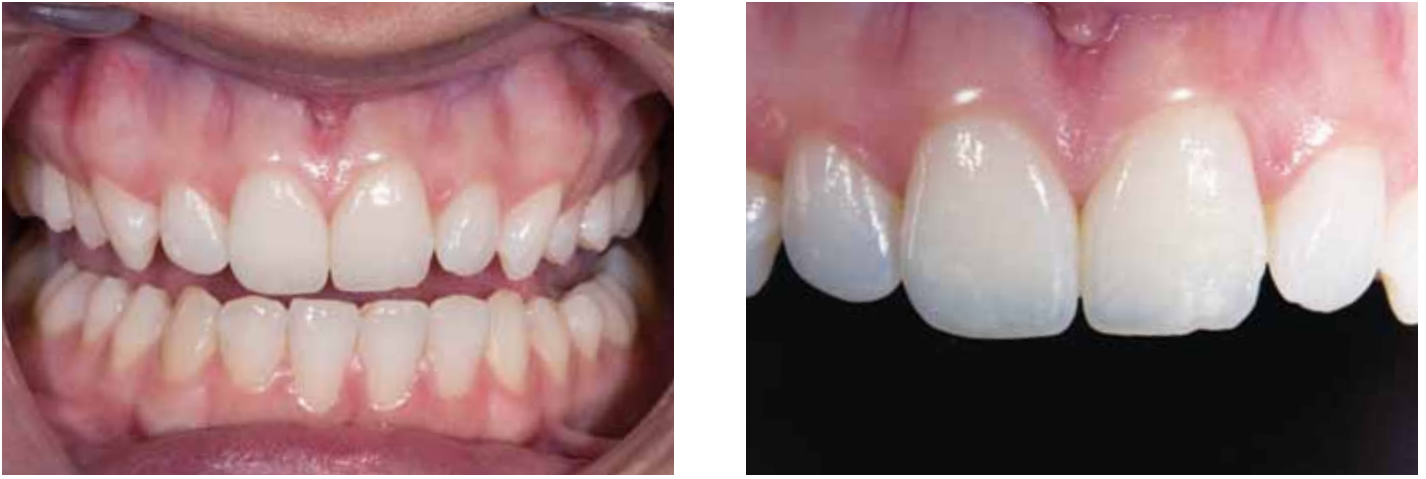
Figures 2a & 2b: Pre-restorative retracted 1:1 and 1:2 views show the developmental malformation of the distal-incisal edge of #9 and the poor positioning and shape of the canines and laterals, resulting in improper incisal embrasure form.

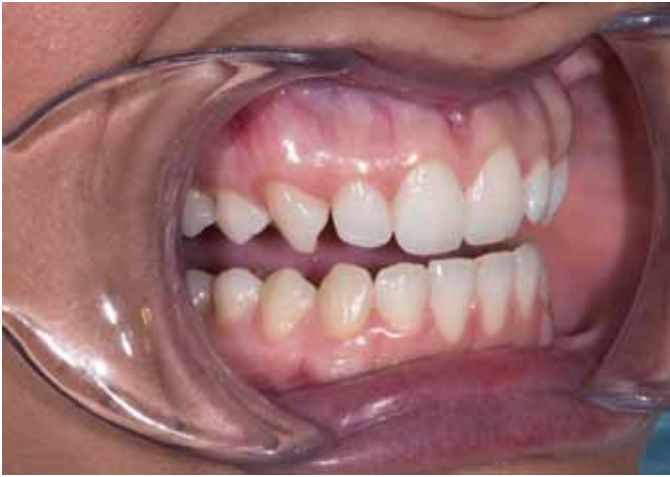
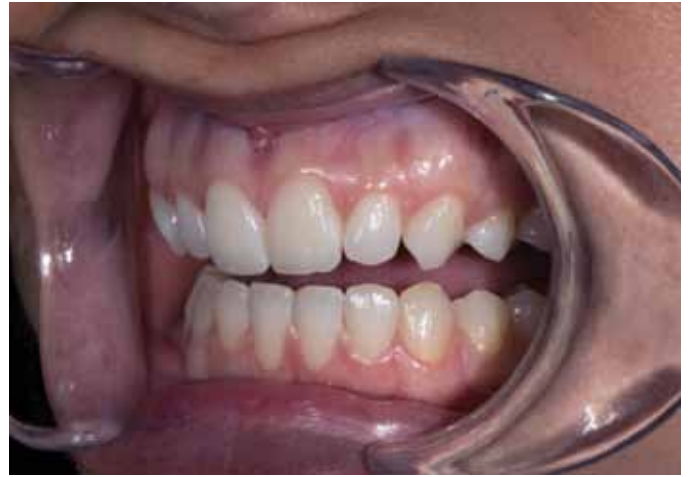
Figures 3a & 3b: Pre-restorative right and left lateral retracted 1:2 views show improper progression of incisal embrasures, Class II canine relationship, and poor transition from anterior to posterior teeth.

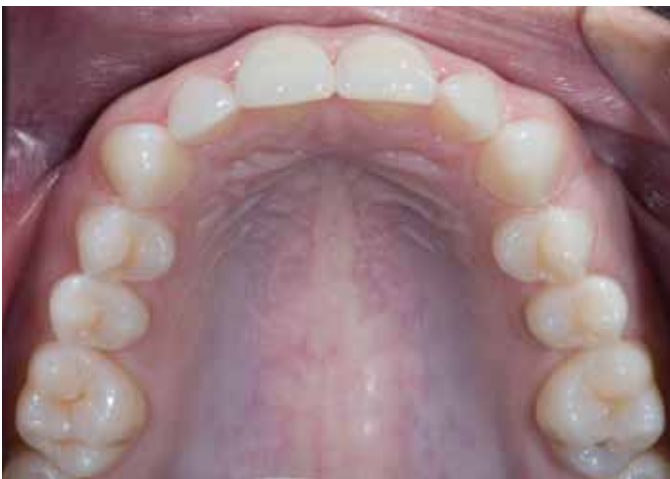
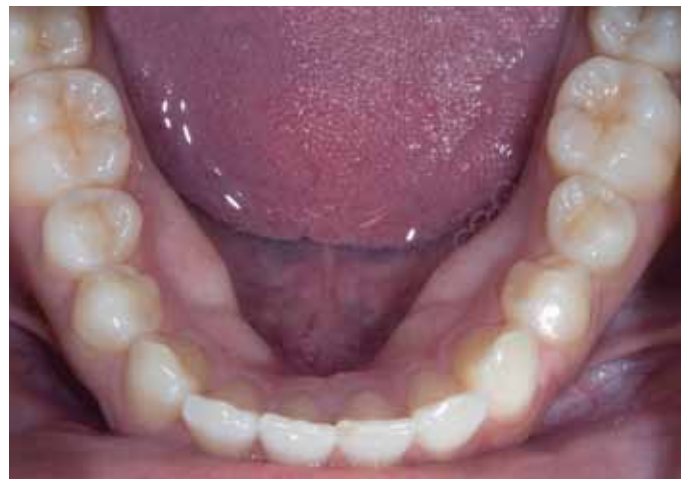
Figures 4a & 4b: Maxillary and mandibular pre-restorative occlusal views demonstrate mild wear on the anterior and molar teeth.

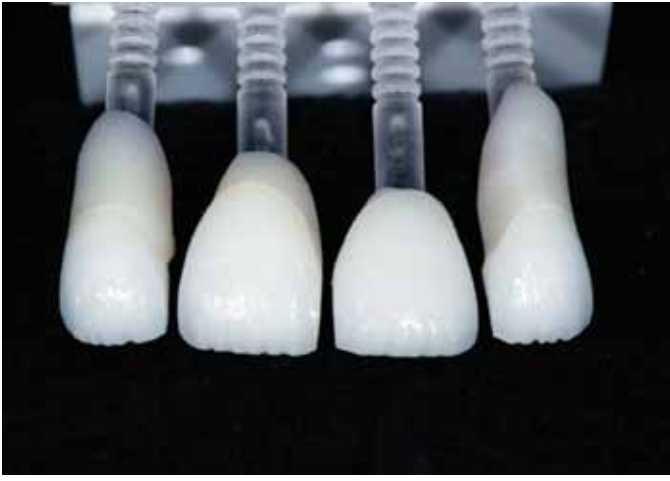
Figure 24: Stain applied.

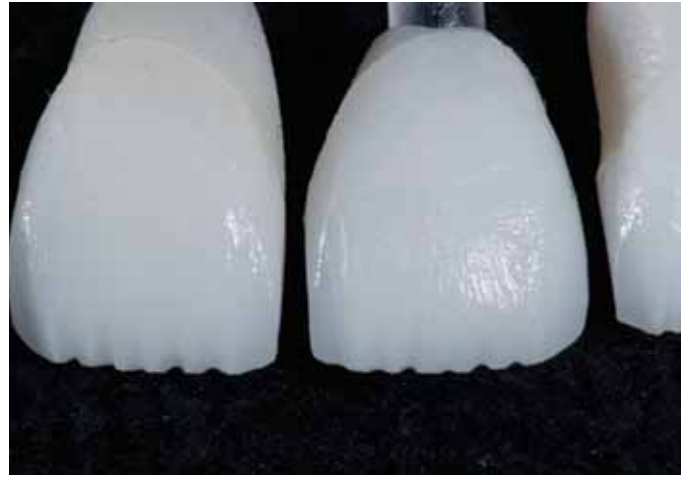
Figure 25: Close-up image of stain application.

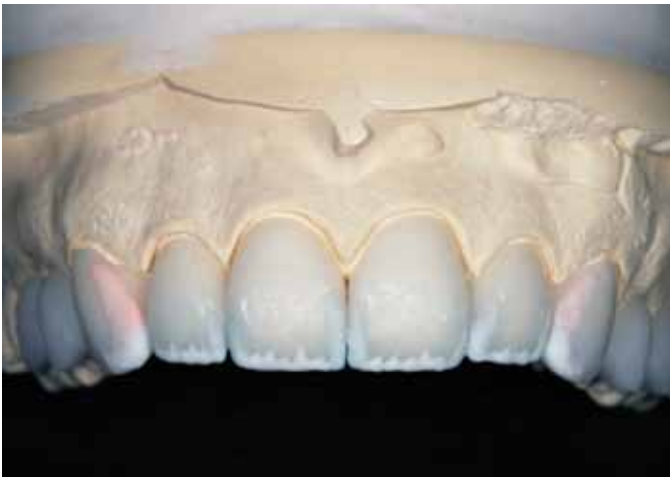
Figure 26: First layer of porcelain started. Pink = 50% Opal 1 and 50% Opal 2; blue = Transparent Blue Fluorescent; white = Opal 2.

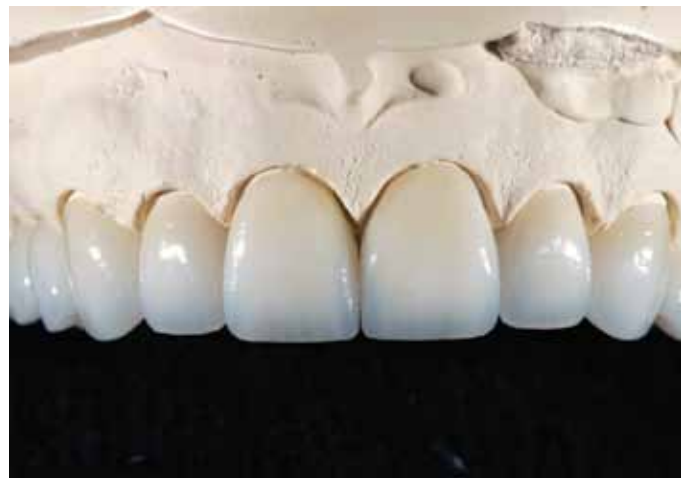
Figure 31: Completed stained and glazed restorations on solid model.

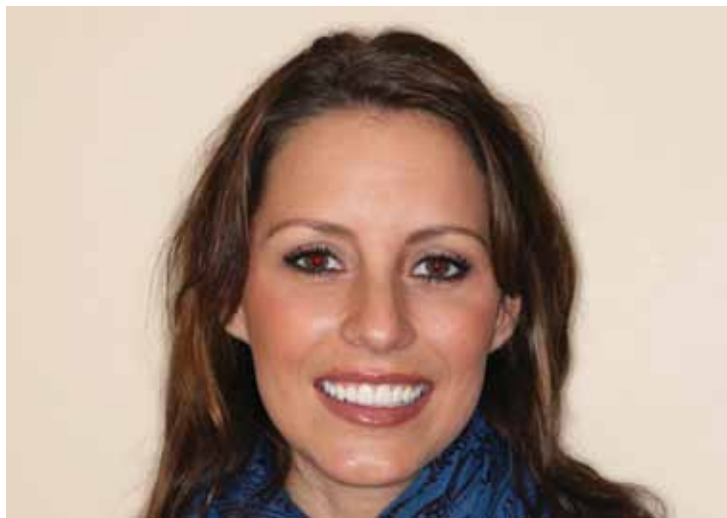
Figure 32: The patient's restored smile.

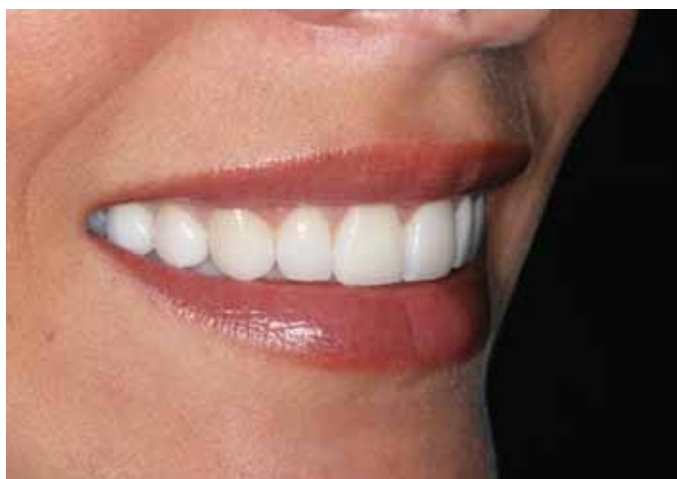
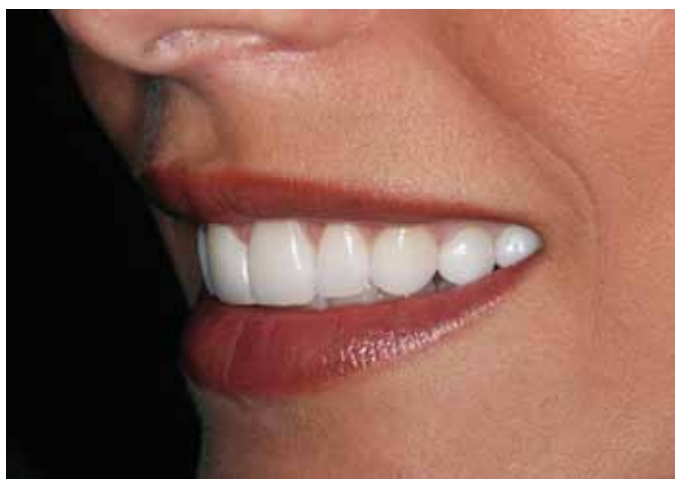
Figures 34a & 34b: Restored right and left lateral full-smile images demonstrate proper progression of incisal embrasures.

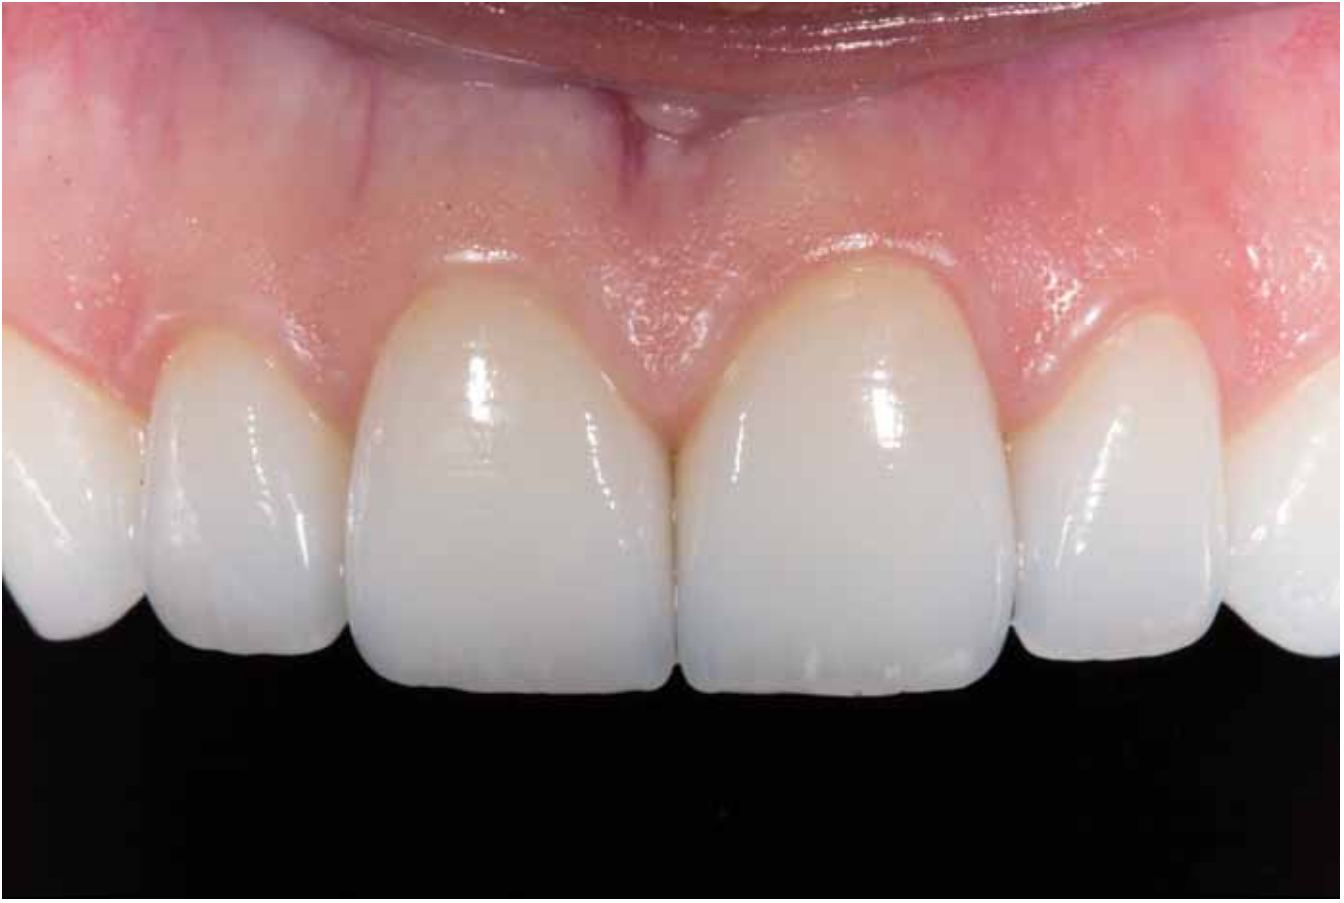
Figure 37: Restored retracted 1:1 view demonstrates proper shape and proportion, resulting in a more harmonious smile. The distal incisal developmental defect on #9 has been corrected to mirror the appearance of #8.

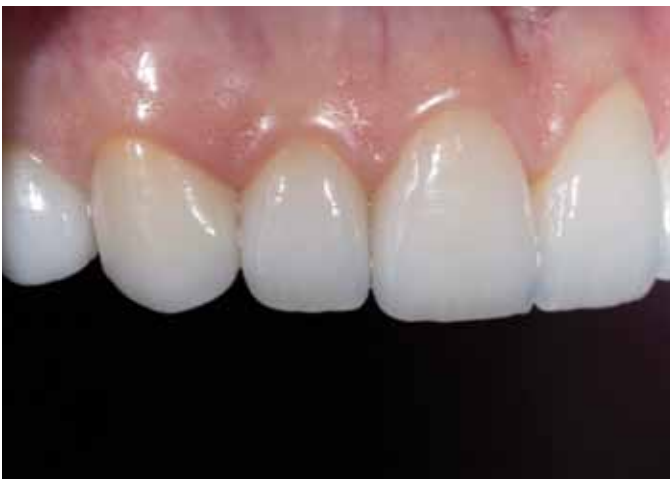
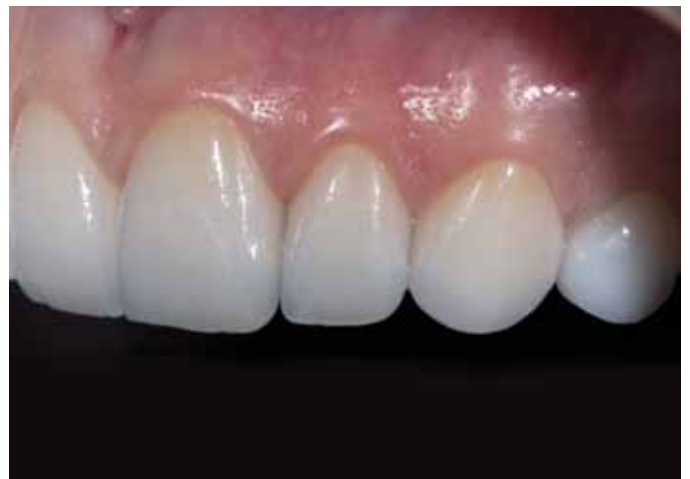
Figures 38a & 38b: Restored retracted right and left lateral 1:1 views demonstrate proper shape and proportion, resulting in a more harmonious smile. The distal incisal developmental defect on #9 has been corrected to mirror the appearance of #8.
